**CWA COMPLIANCE EVALUATION INSPECTION REPORT
U.S. ENVIRONMENTAL PROTECTION AGENCY, REGION 5**

Compliance Evaluation Sampling Inspection

New Horizons Dairy LLC

April 29, 2014

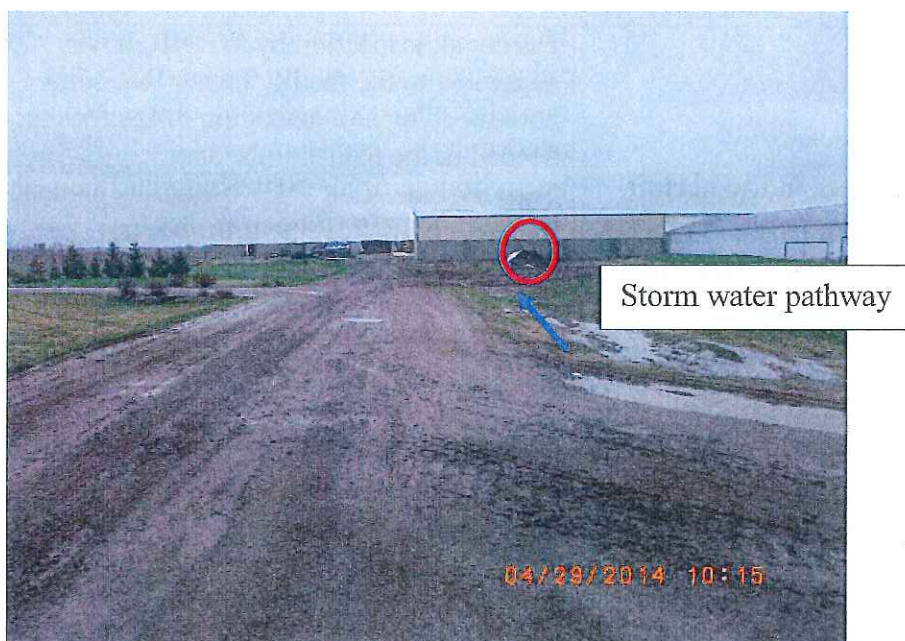
1: IMGP0194

Description: The red circle denotes the location of the open bag of feed. Storm water flows to the west as shown by the blue arrow in the photo.

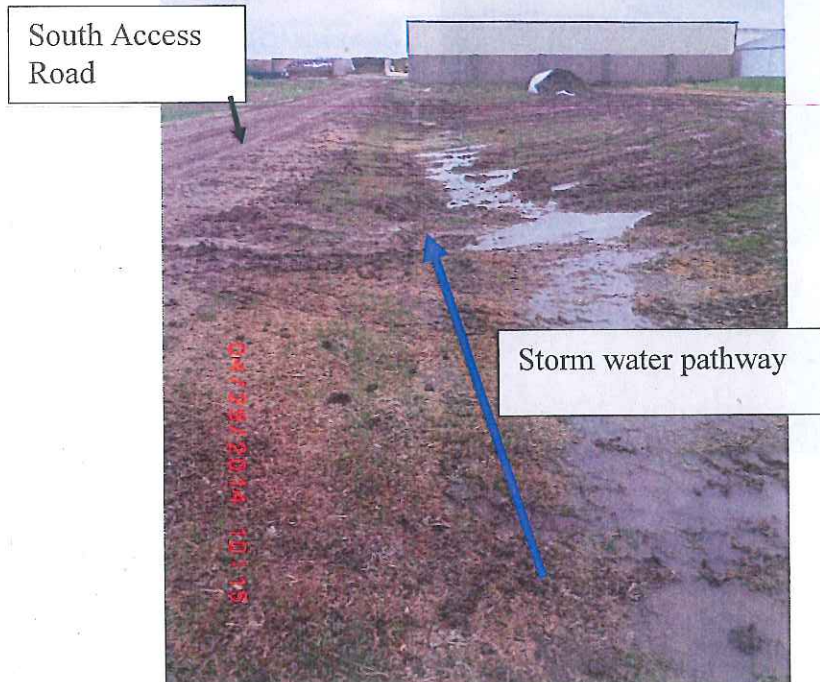
2: IMGP0195

Description: Storm water pathway. Blue arrow denotes the direction of flow. Open bag of feed is north of the South Access Road and east of Dry Feed Barn.

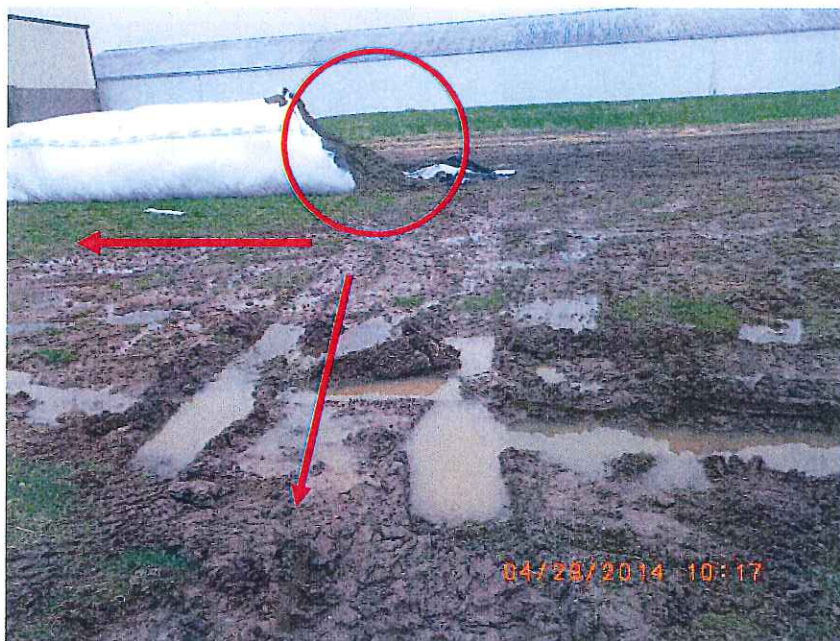
3: IMGP0196

Description: The open bag of feed near the storm water pathway located north of the South Access Road and east of the Dry Feed Barn. The precipitation that comes into contact with the feed from the open bag flows to the west and to the south as denoted by the red arrows. Culverts transport storm water and at the time of the inspection process wastewater to the south into a storm water pathway that flows southwest past the Silage Bunker.

2. EPA observed process wastewater discharging from around the open feed bag located east of the Dry Feed Barn and north of the South Access Road through the culverts into the storm water pathway that flows south into an unnamed intermittent tributary that flows northeast into Apple Creek. Sections 1.1 and 1.3

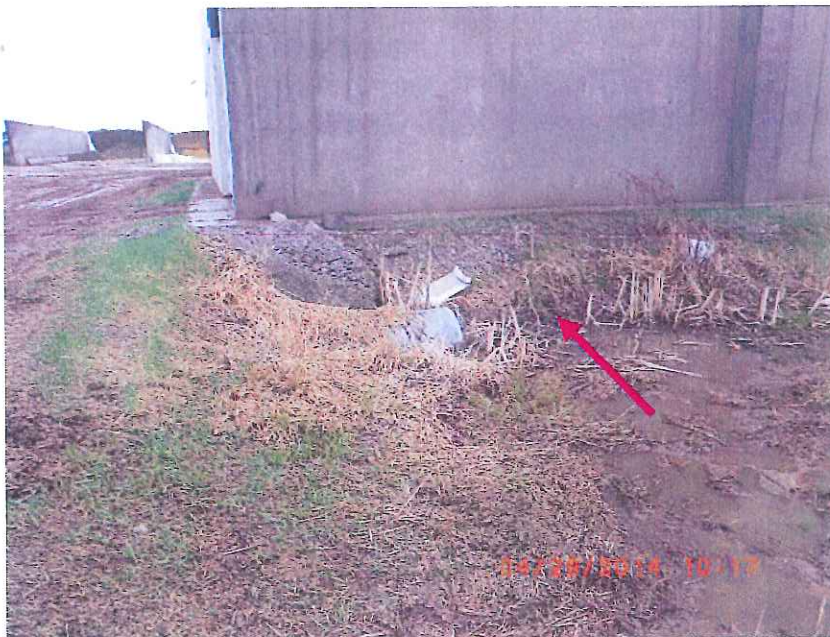
4: IMGP0197

Description: Culvert drains storm water and the process wastewater from the precipitation that came into contact with the feed from the open bag to the south underneath the South Access Road. Red arrow denotes the direction of flow of process wastewater discharging into the storm water pathway.

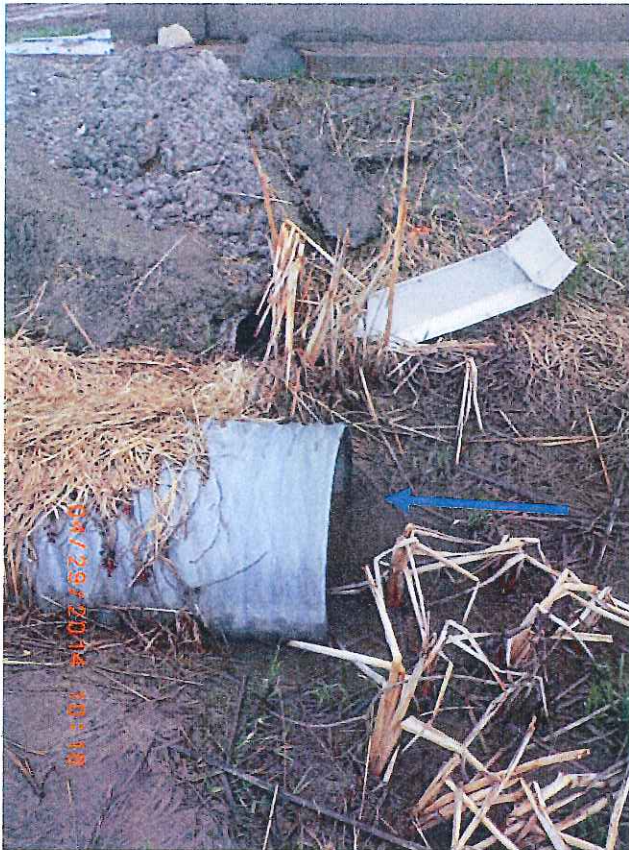
5: IMGP0198

Description: Culvert east of Dry Feed Barn drains storm water pathway to the south. The process wastewater from the open bag of feed flowed into this storm water pathway to the south. The blue arrow denotes direction of flow.

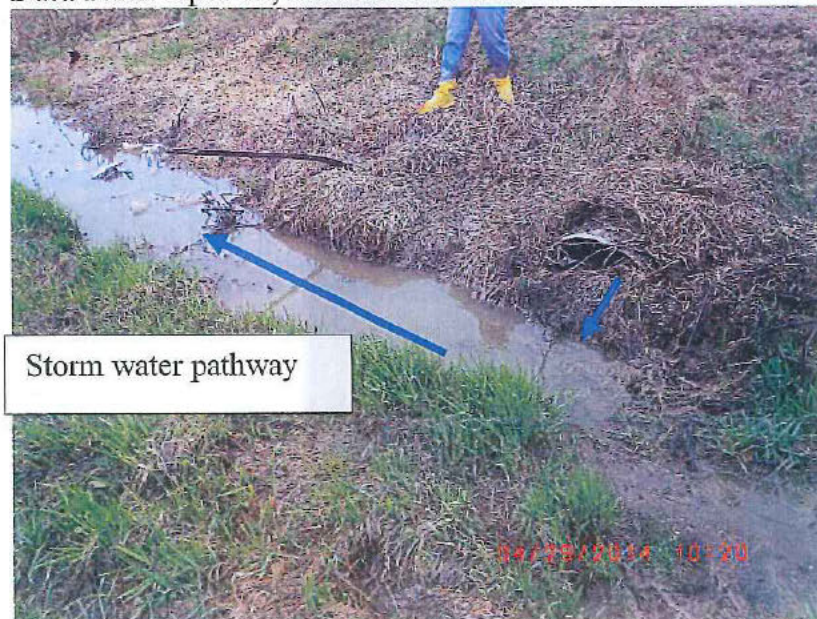
7: IMGP0200

Description: Culvert outlet on the south side of South Access Road draining the storm water pathway on the north side of the South Access Road.

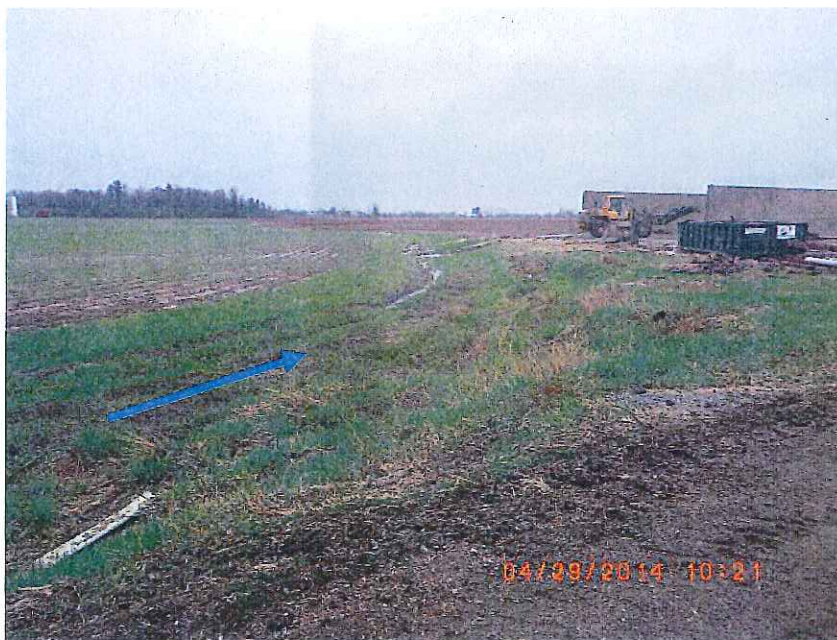
8: IMGP0203

Description: Storm water pathway located on the east side of Silage Bunkers and concrete pad continues to flow to the south into an unnamed intermittent tributary.

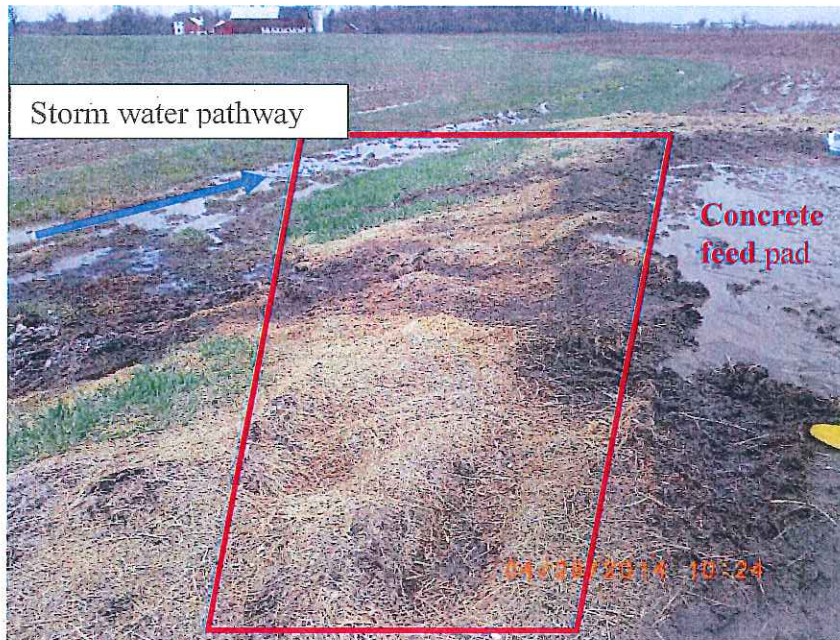
11: IMGP0209

Description: Silage leachate and feed is discharged from the Silage Bunkers and concrete pad into the storm water pathway. The brown material outlined in the red box is the feed.

1. EPA observed process wastewater discharging from the Silage Bunkers and the concrete pad into the storm water pathway that flows south into an unnamed intermittent tributary that flows northeast into Apple Creek. Sections 1.1 and 1.3

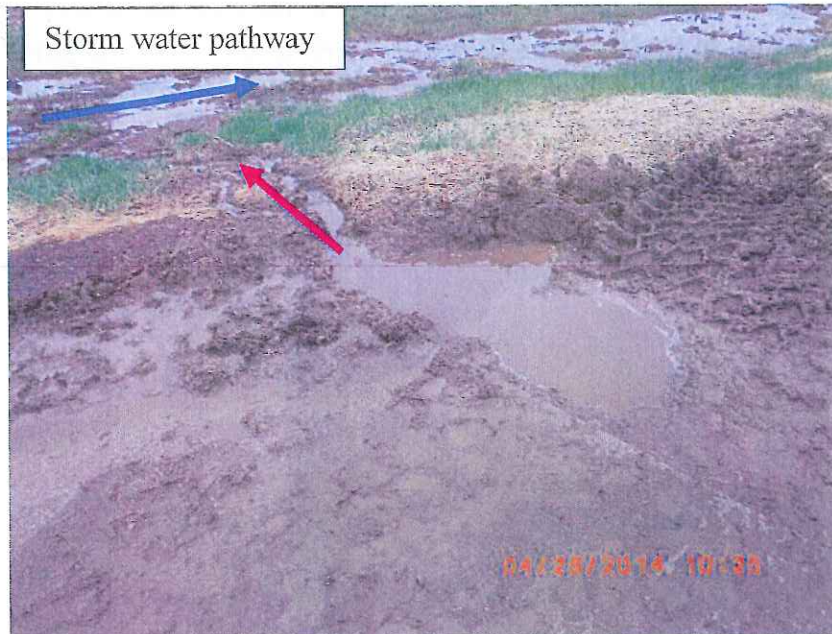
12: IMGP0211

Description: Channels of process wastewater and feed from the Silage Bunkers and concrete pad discharged into the storm water pathway.

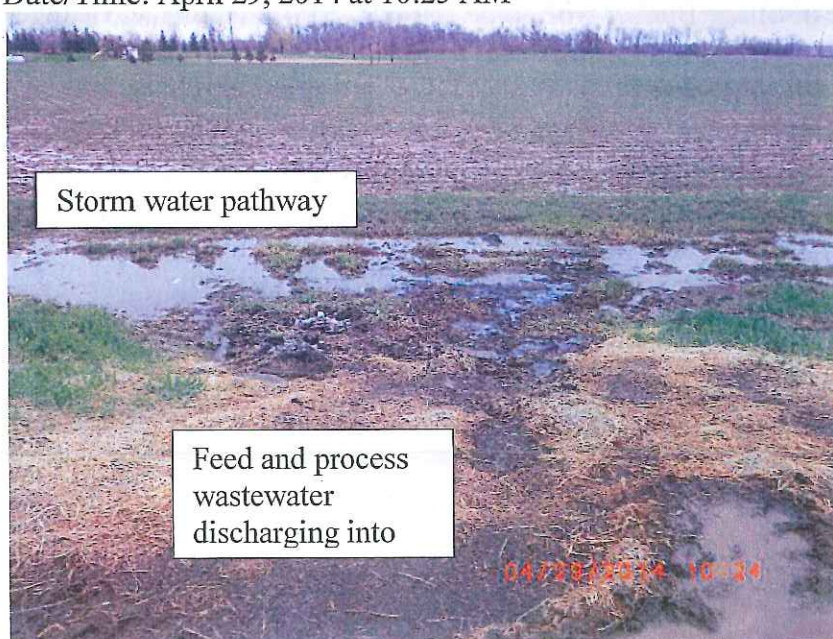
13: IMGP0210

Description: Silage leachate and feed discharged into the storm water pathway from the Silage Bunkers and concrete pad.

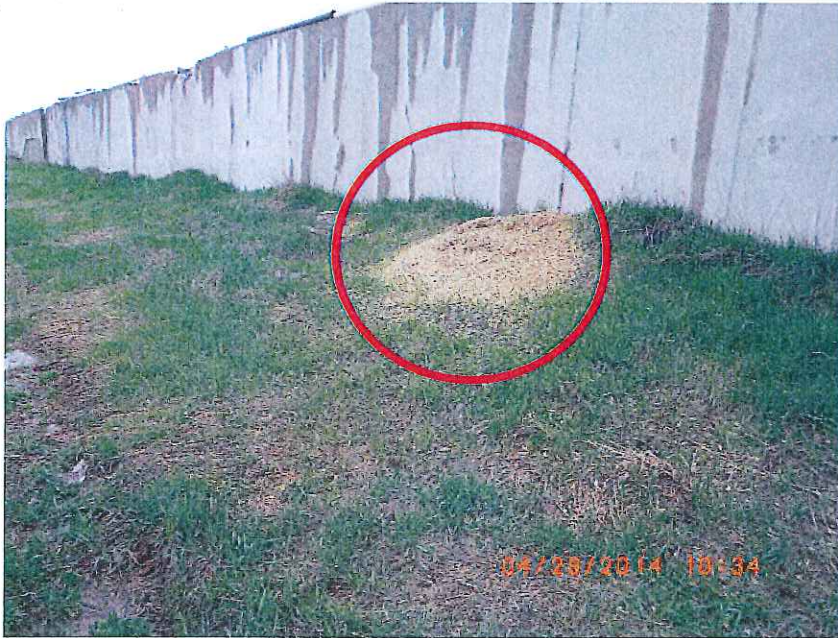
14: IMGP0214

Description: South side of Silage Bunker with some spilled feed from the Silage Bunker denoted by the red circle.

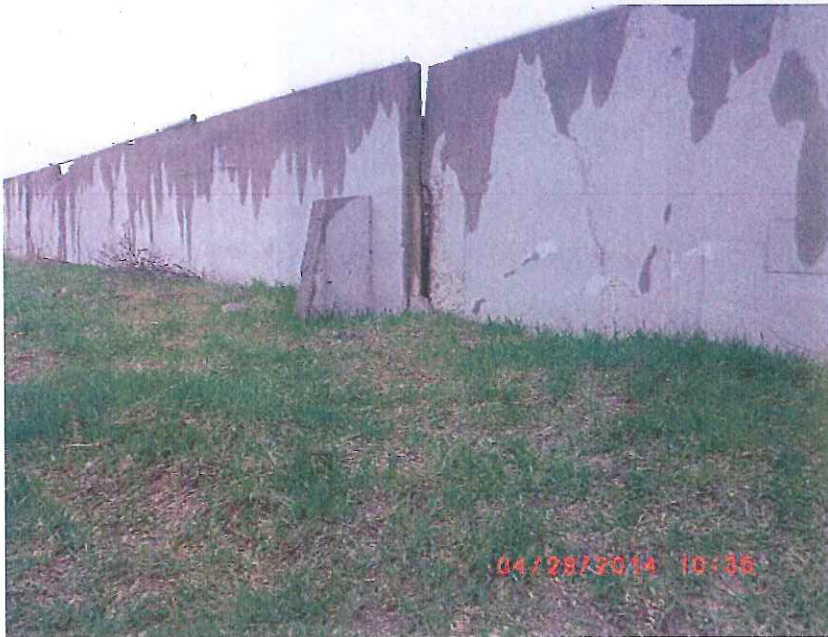
15: IMGP0215

EPA then walked around the Silage Bunkers to south and then to the west and observed spilled feed along the west side of the Silage Bunkers. EPA continued to walk along the west side of the Silage Bunkers to the north, no additional spilled feed was observed. However, EPA did observe cracks in the wall of the Silage Bunkers.

Description: Crack in the Silage Bunkers wall.

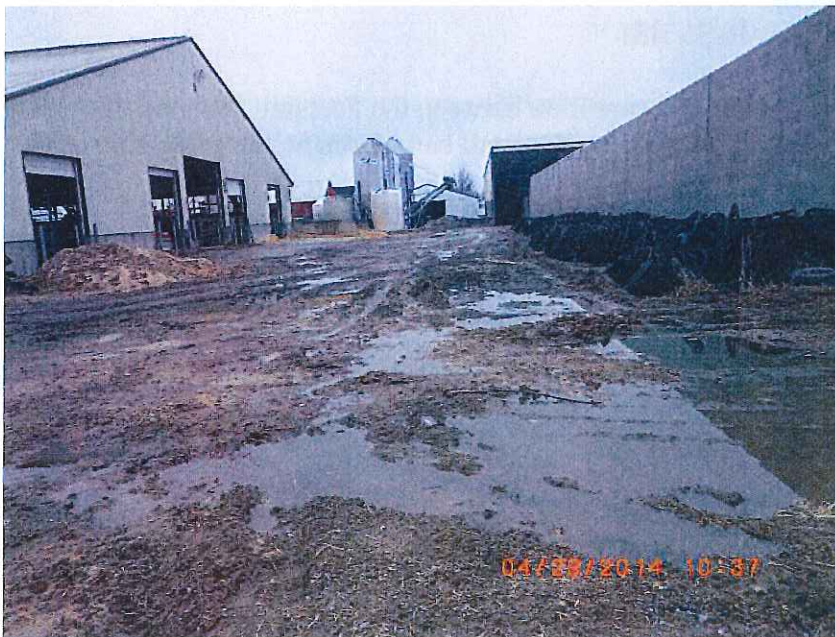
17: IMGP0217

Description: Between the Freestall Barn and Silage Bunkers. Clean sand stored outside the Freestall Barn door.

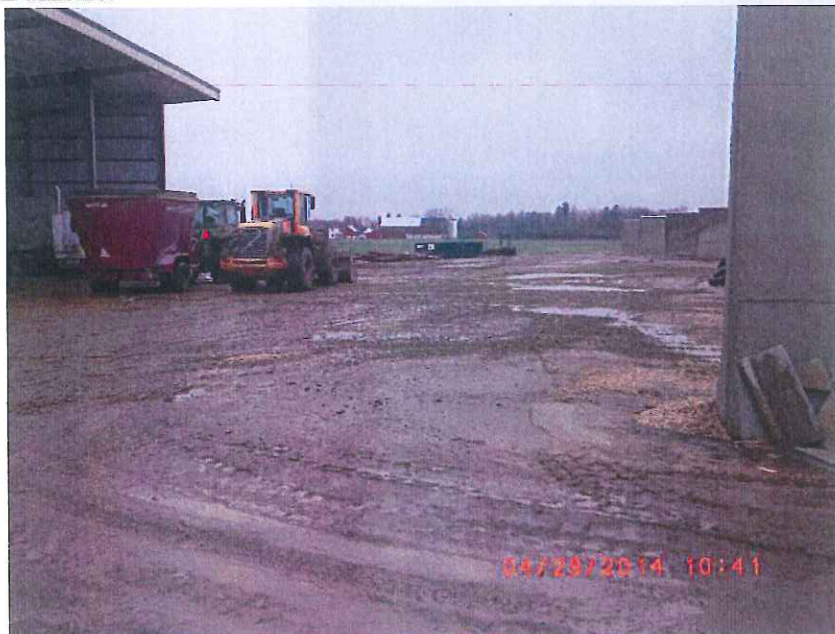
18: IMGP0219

Description: Between Dry Feed Barn and Silage Bunkers feed was spilled on the concrete pad.

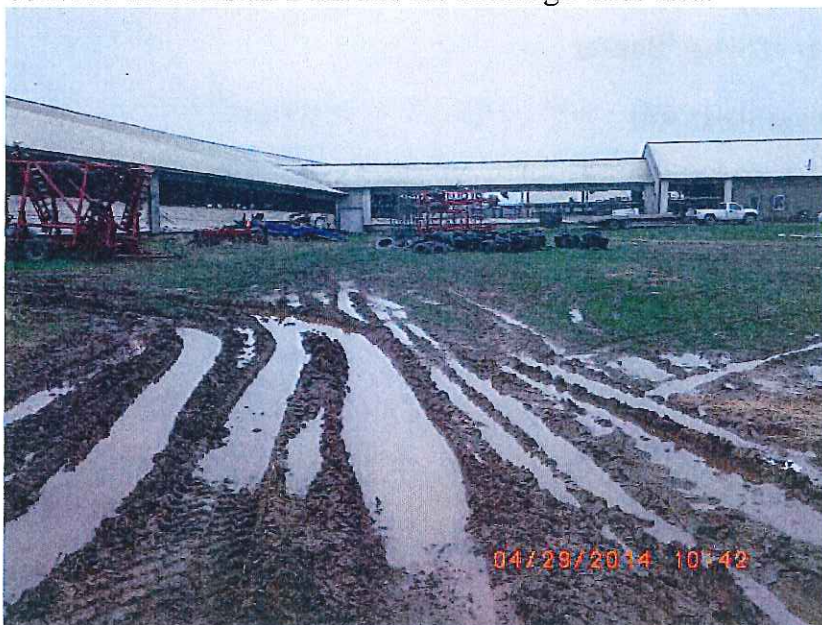
20: IMGP0223

EPA observed vehicle ruts through-out the production area and on the vegetated areas between the Freestall Barn and the Milking Parlor area.

Description: Vegetation torn up from vehicle traffic.

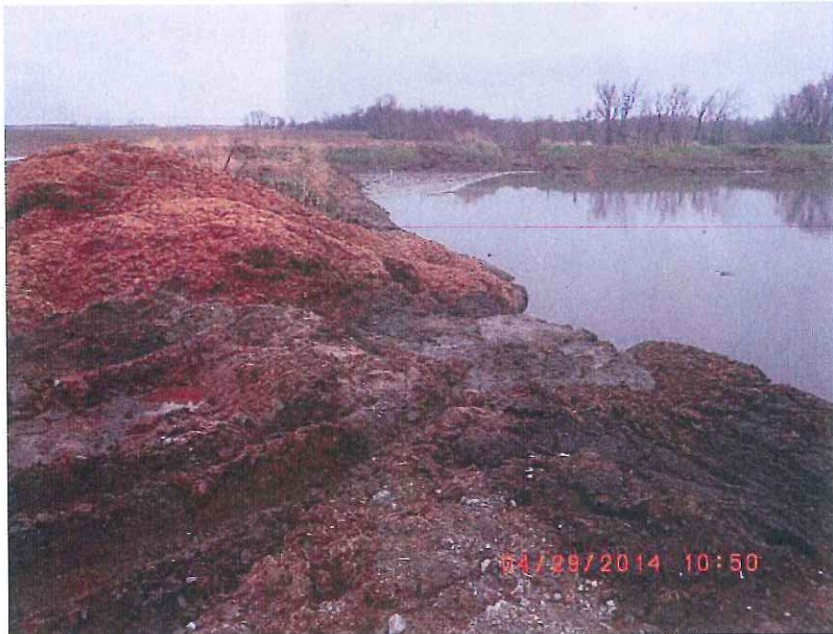
23: IMGP0228

EPA observed process wastewater from the used bedding and manure stockpiled on the south side of the Earthen Storage Structure discharging into the storm water pathway to the south. EPA also observed placentas on the inner bank of the southeast corner of the Earthen Storage Structure.

Description: Used bedding and feed on the south side of Earthen Storage Structure.

3. EPA observed process wastewater discharging from the stacked pile of manure and used bedding located on the south side of the Earthen Storage Structure into the storm water pathway that was flowing northwest toward Apple Creek. Section 1.1 and 1.3

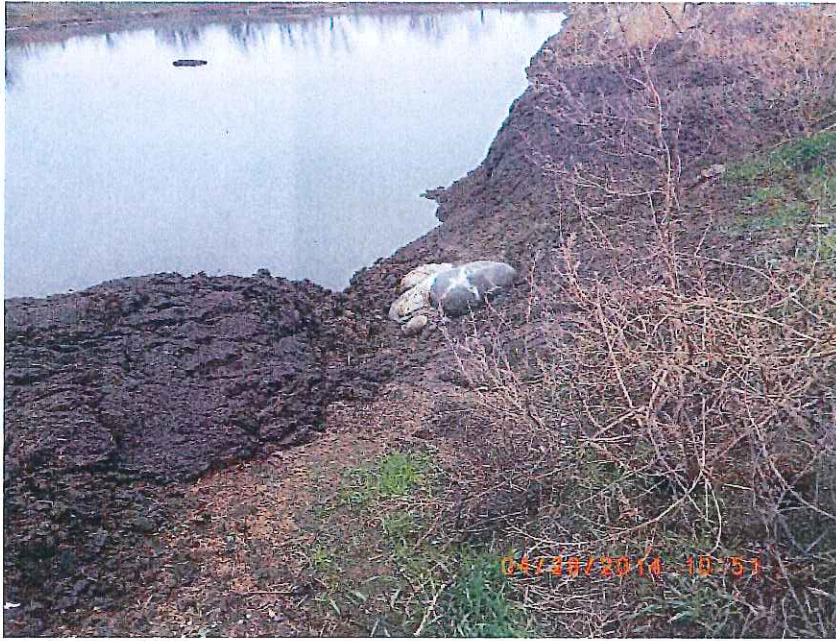
24: IMGP0229

Description: Manure and placentas on the inside berm of the Earthen Storage Structure.

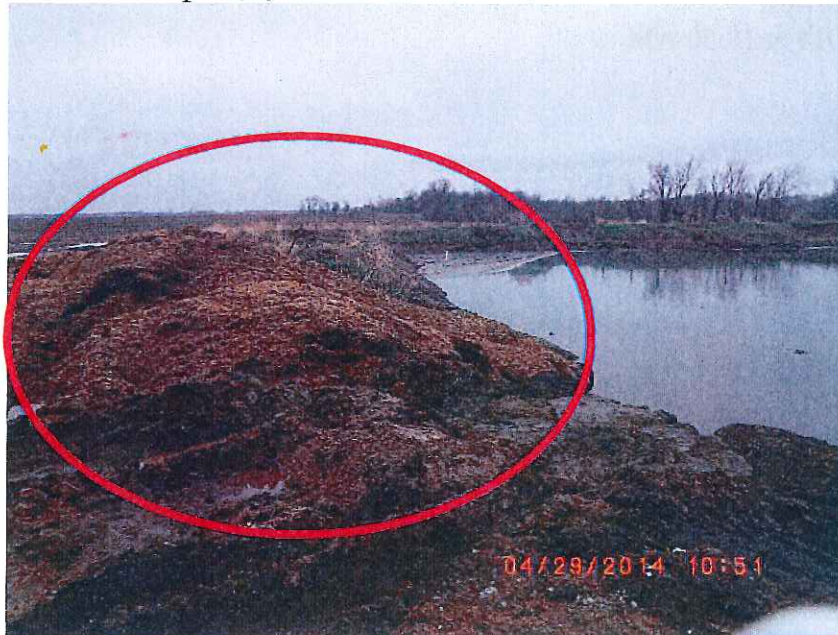
25: IMGP0230

Description: Manure and used feed/bedding on the south side of the Earthen Storage Structure.

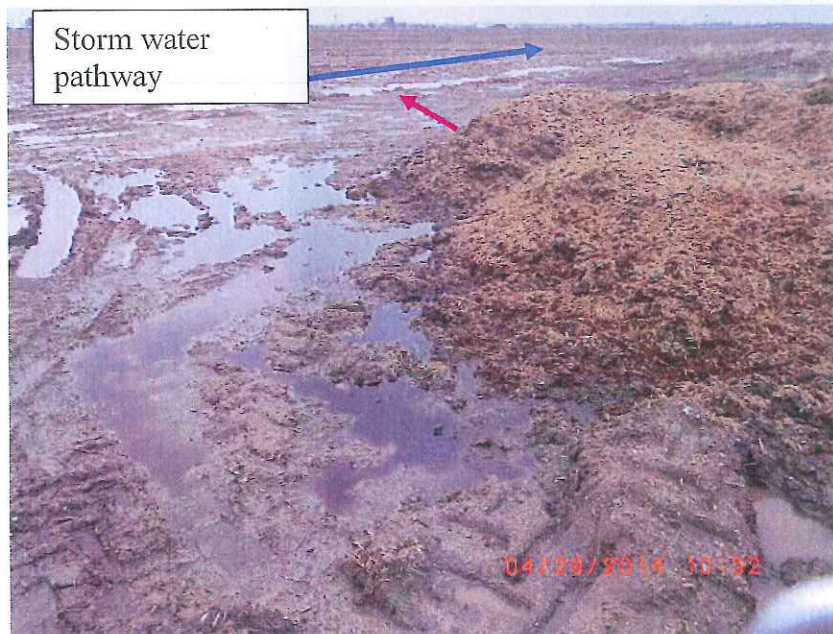
26: IMGP0231

The stockpiling of used bedding and manure stored on the south side of the berm of the Earthen Storage Structure in the land application field.. The process wastewater from the pile discharged into a stormwater pathway in the agricultural field that flowed toward Apple Creek.

Description: Used bedding and manure in the rivets made by vehicles discharging into the storm water pathway that flows into Apple Creek to the northwest.

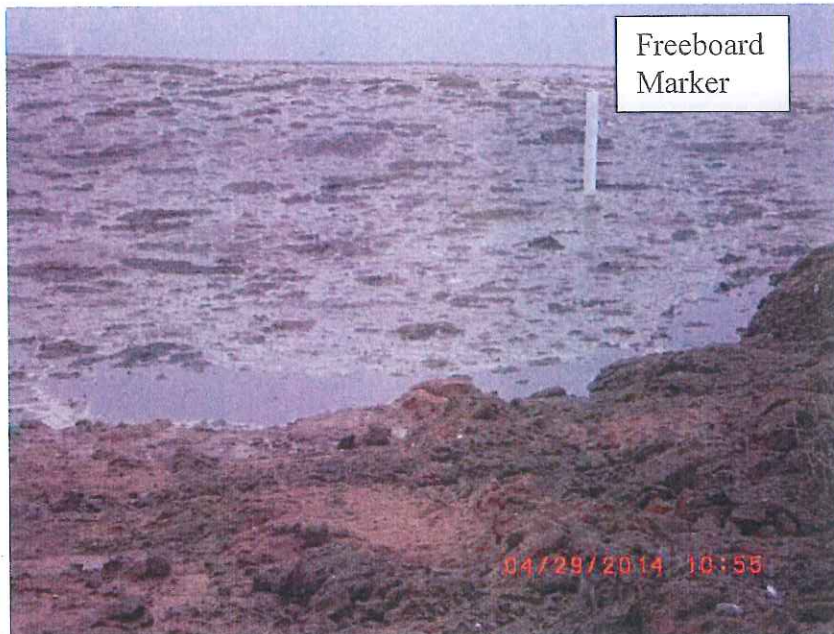
28: IMGP0234

Description: Freeboard Marker in the Earthen Storage Structure.

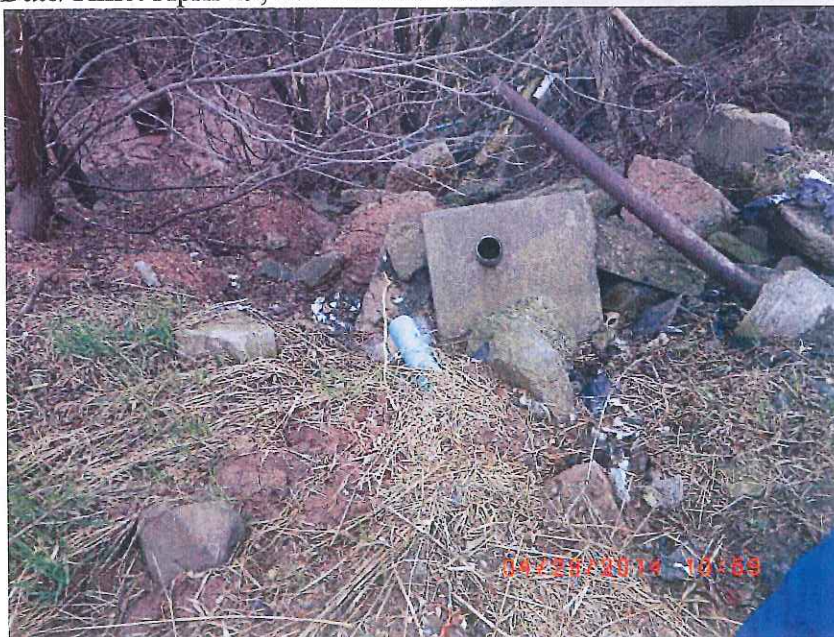
29: IMGP0236

Description: Debris along the bank of Apple Creek.

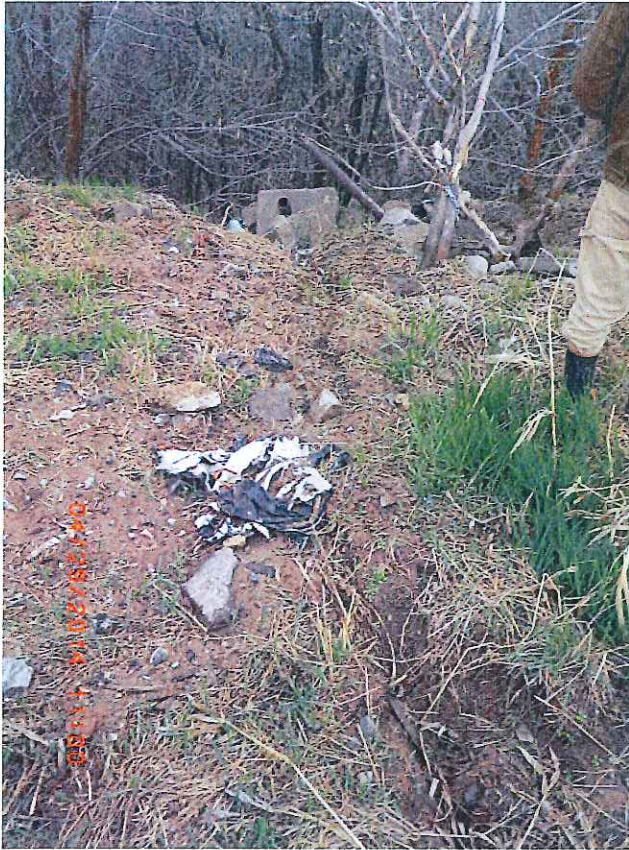
30: IMGP0238

Description: Storm water pathway through the land application field K-L, which created an erosional channel down the bank to Apple Creek.

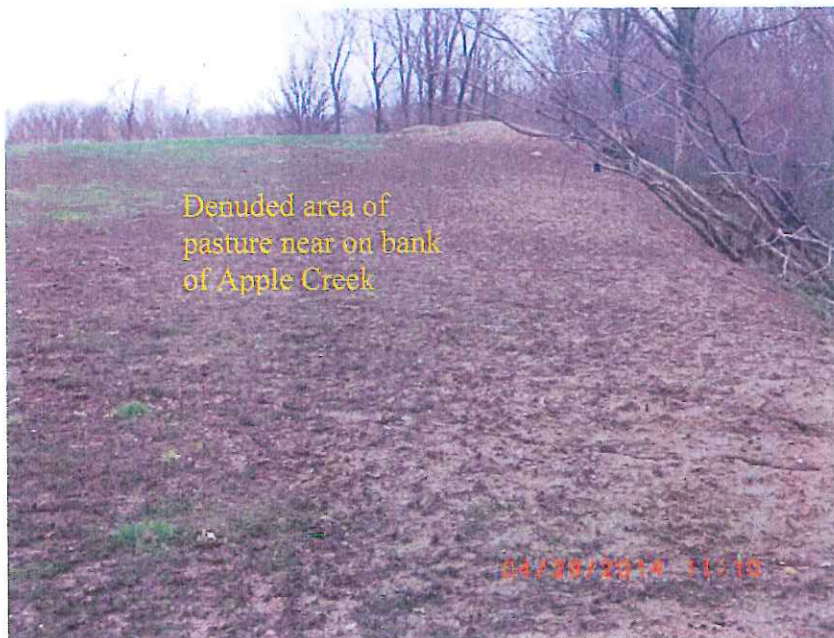
31: IMGP0240

Description: Pasture area on the west side of Earthen Storage Structure east of Apple Creek, which is denuded along the bank of Apple Creek.

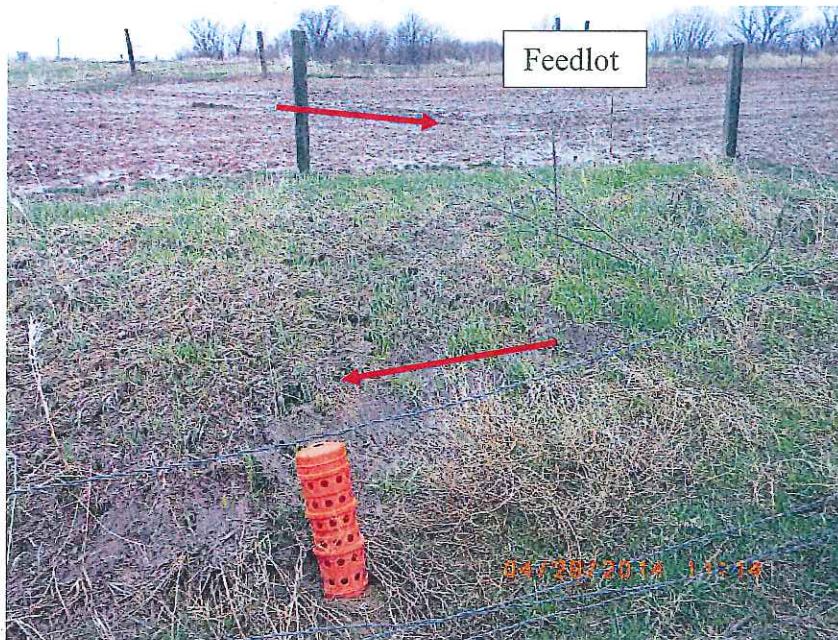
32: IMGP0243

As EPA was walking through the pasture behind the feedlot north of the Freestall Barn, EPA observed a tile inlet. The tile was fenced in, so the cows could not denude the area around it. However, south of the tile was a feedlot north of the Freestall Barn. EPA observed runoff from the feedlot flowing toward the tile inlet. EPA continued walking through the pasture to find safe access down the embankment to Apple Creek to try and find where the tile outlets. EPA walked the bank of Apple Creek and found a tile outlet on the northwest side of Apple Creek. EPA did not sample the tile outlet because they did not have proper gear to wade in Apple Creek and observe if the tile was discharging.

Description: The tile inlet north of the Feedlot and north of Freestall Barn.

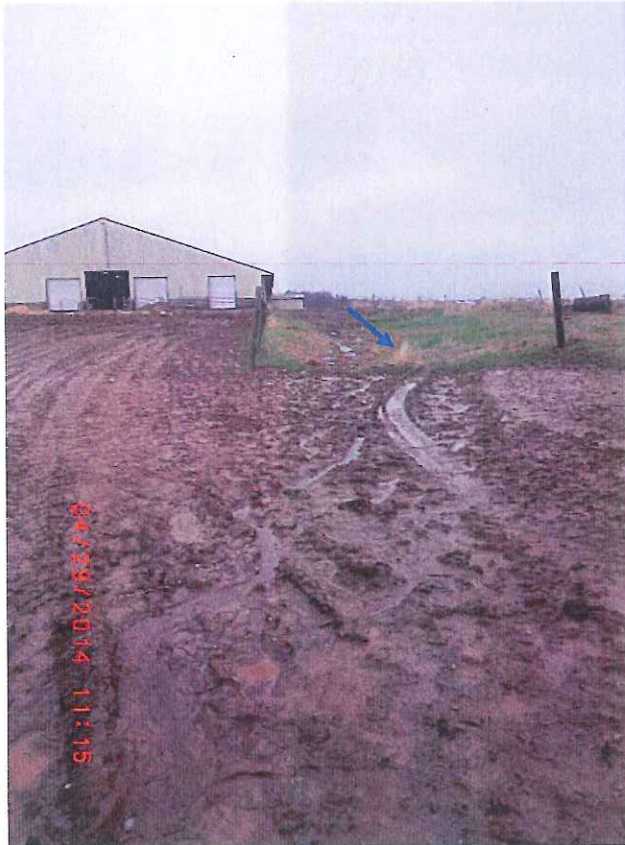
33: IMGP0244

Description: West of Freestall Barn and south of the Feedlot is a storm water pathway, denoted by the blue arrow that conveys storm water through the Feedlot.

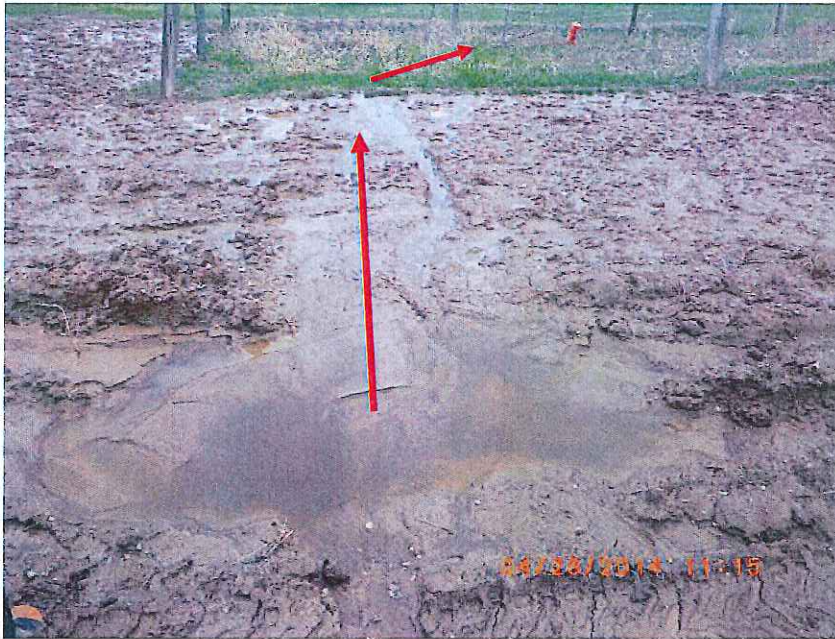
34: IMGP0246

Description: The red arrows denote process wastewater discharging from the Feedlot. runoff flowing off Feedlot toward the tile inlet.

5. EPA observed process wastewater from the feedlot on the north side of the Freestall Barn flowing toward the tile inlet that outlets to Apple Creek. Section 1.1 and 1.3.

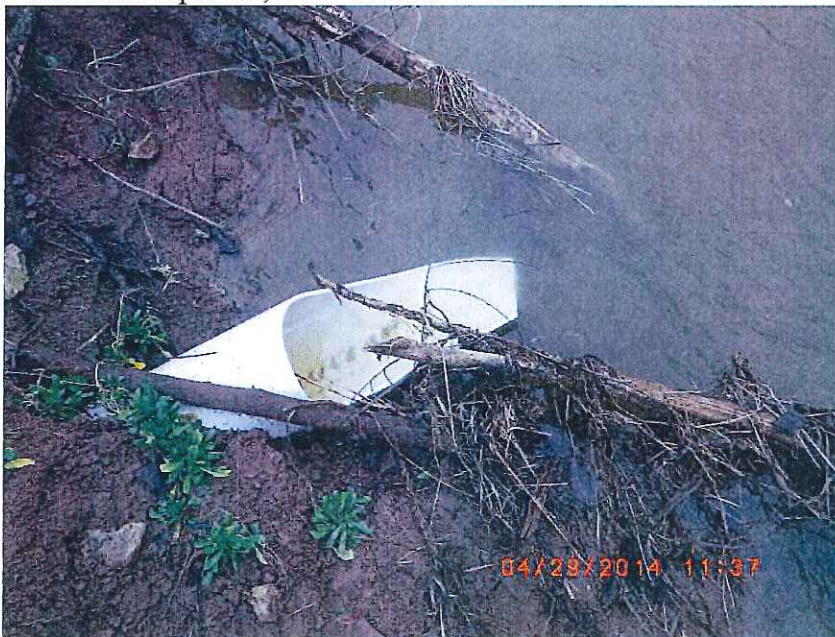
35: IMGP0247

Description: The tile outlet that discharge from the pasture, but not sure of the what tile inlet is connected to this tile outlet.

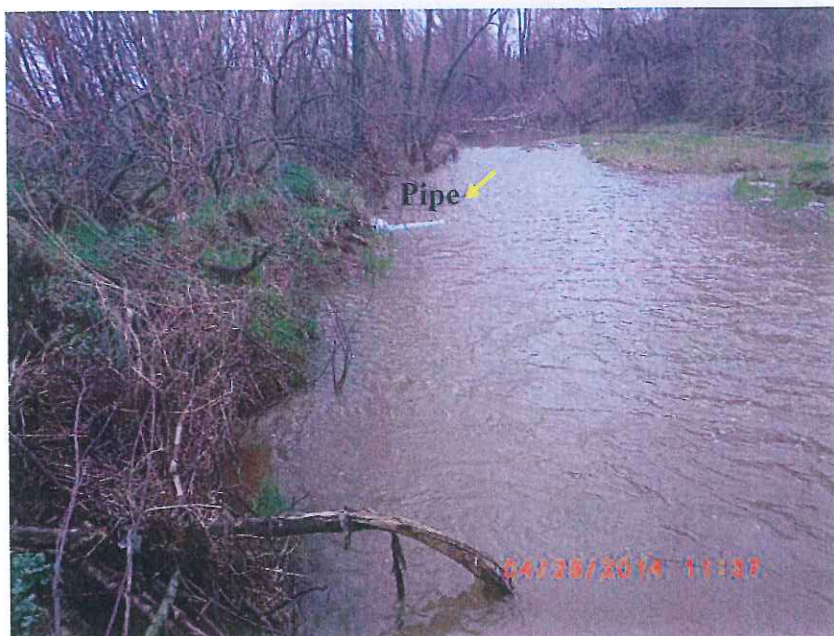
36: IMGP0248

Description: Apple Creek – Yellow arrow denotes the tile outlet from the tile within the pasture into Apple Creek.

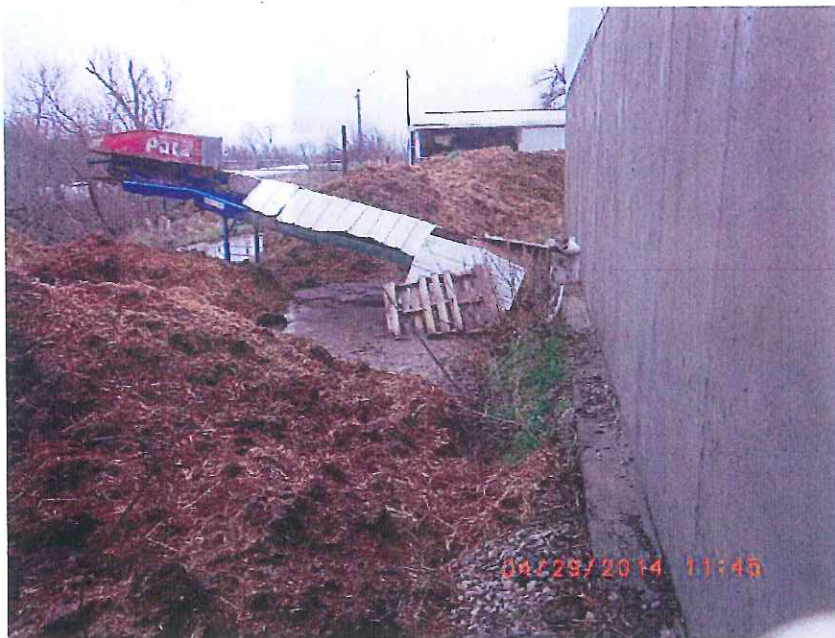
39: IMGP0254

EPA walked along the edge of the concrete pad to get to the other side to get down to Apple Creek to observe if the process wastewater had overflowed the berm and was discharging into Apple Creek. EPA observed more bags of feed on the east side of the production area. The feed was contained to the area around the bags and no leachate from the feed was flowing toward Apple Creek, at the time of the inspection. EPA walked down to Apple Creek to observe the bank to look for runoff from the concrete pad off the east side of the Heifer Barn. EPA did not observe any runoff into the Apple Creek at the time of the inspection. However, according to WDNR this was not an approved stacking site.

Description: Used bedding and manure stockpiled on the concrete pad on the east side of the Calf Barn.

4. EPA observed process wastewater on the concrete pad east of the Calf Barn attached to the Fresh Cow Barn. The process wastewater could overflow the concrete berm and flow down the embankment on east side of the facility discharging into Apple Creek because the pad was not designed, operated, and maintained to store process wastewater for storm event greater than the 25-year/24 hour storm event. Section 1.1 and 1.3

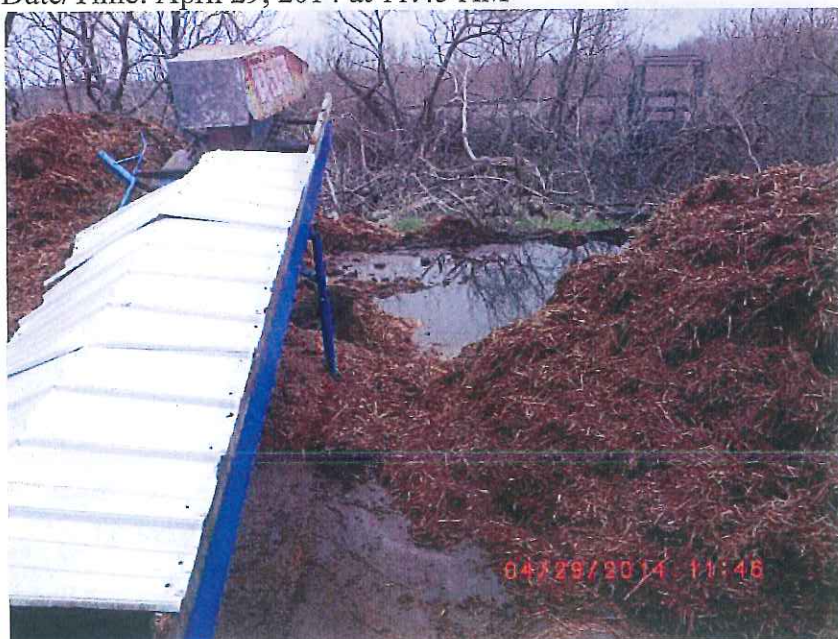
40: IMGP0257

Description: Used bedding and manure that was stockpiled on the concrete pad mixed with storm water.

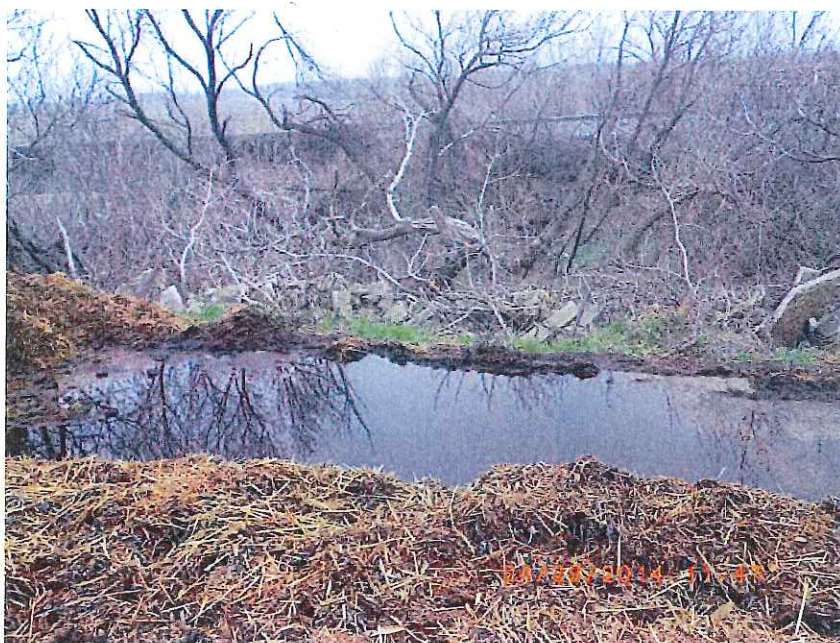
41: IMGP0258

Description: Process wastewater from the used bedding and manure.

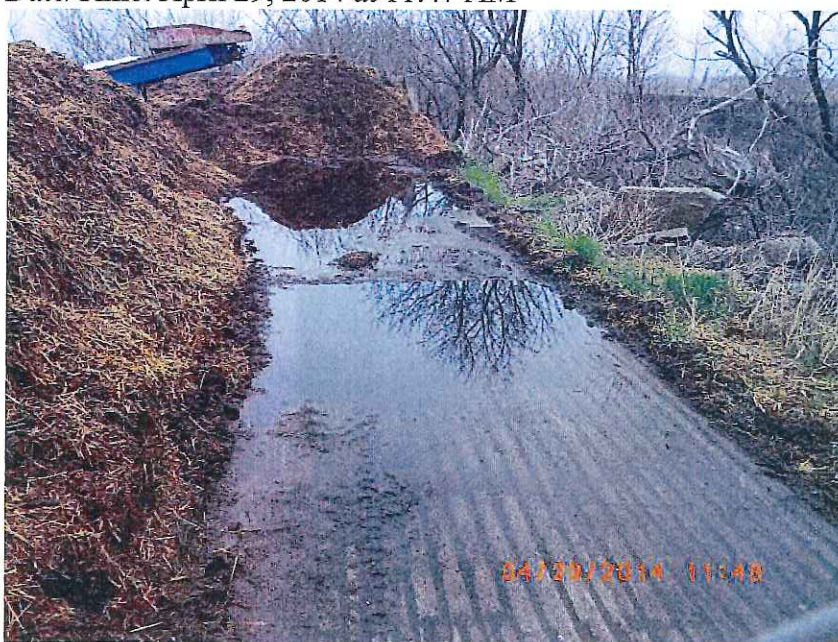
42: IMGP0259

Description: Used bedding and manure stockpiled on the concrete pad east of the Calf Barn mixed with storm water.

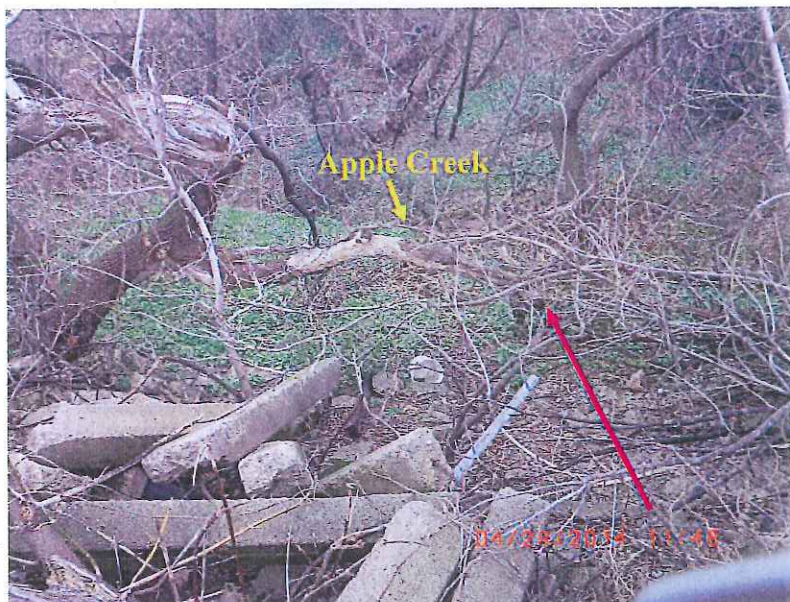
43: IMGP0260

Description: Debris on the bank of Apple Creek on the east side of the Calf Barn. The red arrow denotes the channel where runoff from the concrete pad overflows down the bank to Apple Creek.

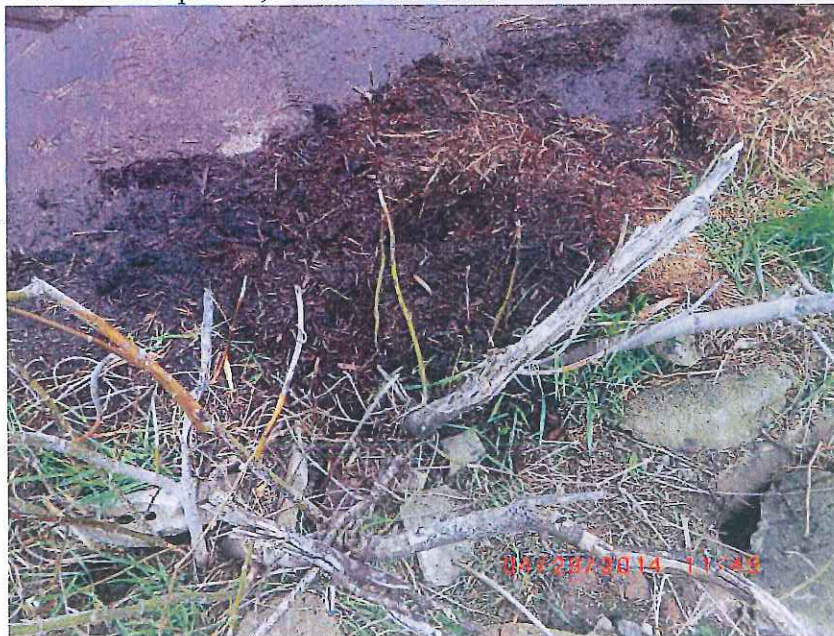
44: IMGP0262

Description: Used bedding over the edge of the concrete pad on the east side of the Calf Barn.

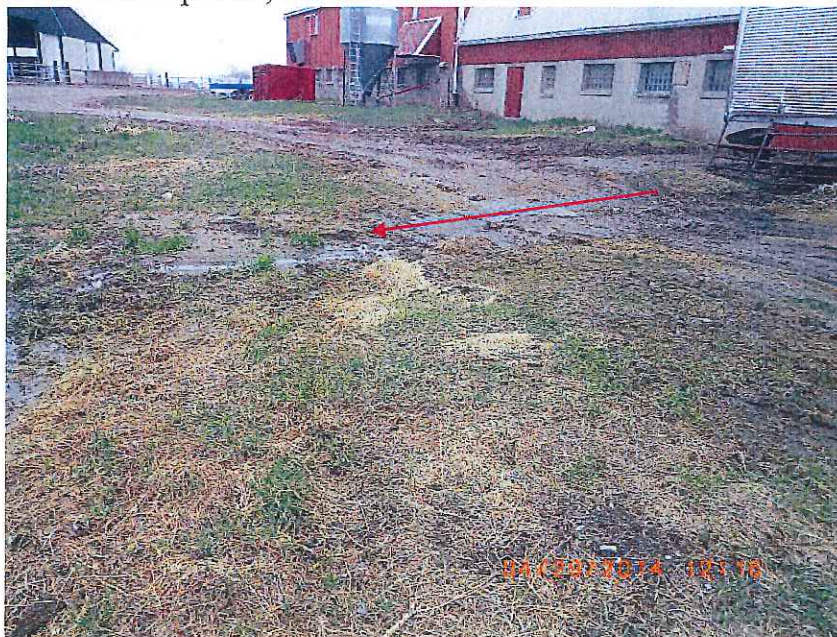
46: IMGP0273

Description: Runoff of manure mixed with storm water near the Fresh Cow Barn.

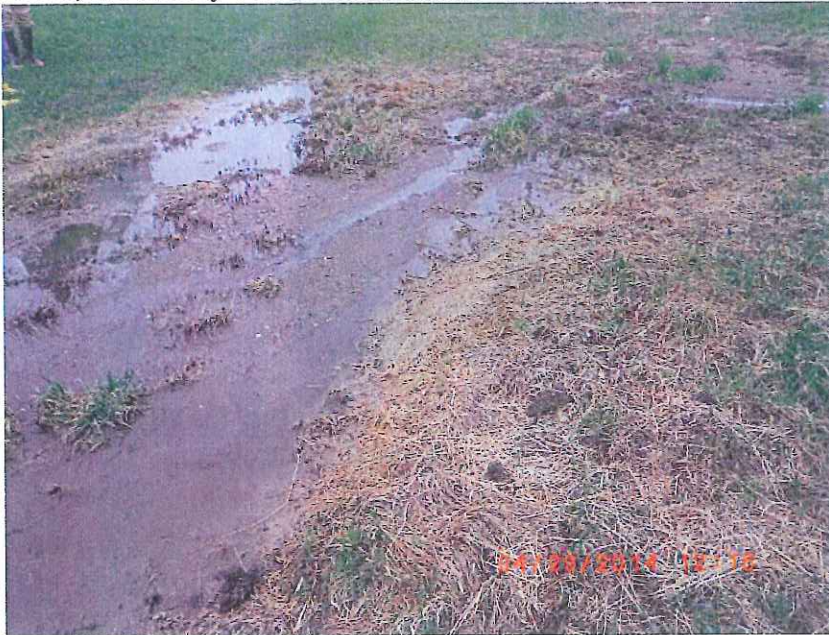
47: IMGP0274

EPA met up with the facility owner and rewalked some of the production area: EPA observed manure mixed with storm water flowing toward the storm water pathway from under the Fresh Cow Barn. The facility owner stated that the manure must of spilled while cleaning out the Fresh Cow Barn because the area under the Fresh Cow Barn was conveyance for clean storm water. EPA asked the facility owner how the tile lines in the pasture were connected and which tile inlet was connected to what tile outlet in Apple Creek; the facility owner stated that he was not sure.

Description: Manure mixed with storm water flowed from under Fresh Cow Barn to the storm water pathway

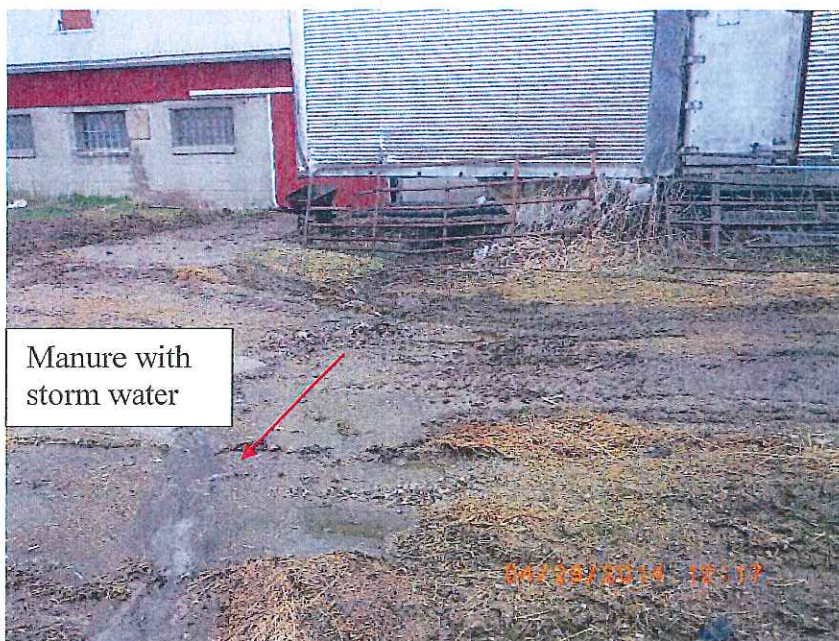
48: IMGP0275

Description: Manure and feed mixed with storm water flowing toward the storm water pathway coming from the Fresh Cow Barn, as denoted by the red arrow.
